Manhole Inspection Summary

Manhole # S29MM1015MH

Insp Date: **4/19/07 1:03 PM**

Location Address: **4425 MEADOW LN**

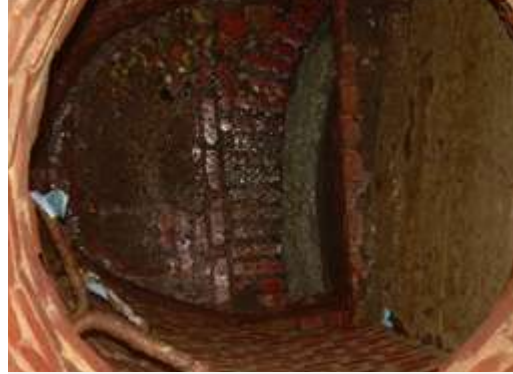
Top View

Corroded steps. Evidence of surcharge - Bench debris.

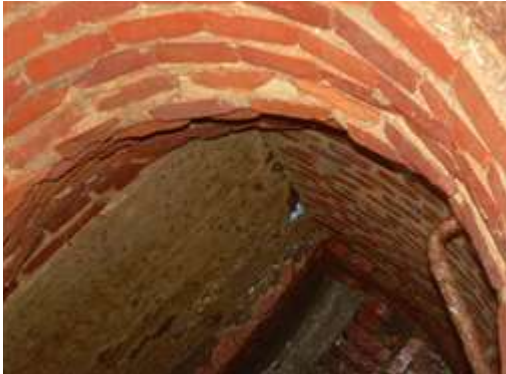
Defect

Steps Count: **5** Missing: **0** ☒ **Corroded**

Corroded step

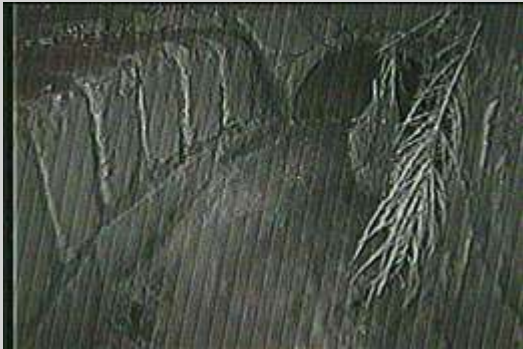
8 in. Circular Gravity Sewer Pipe Out @ 12 O'Clock

Barrel root intrusion and infiltration.

Infiltration: **Evidence** Pipe Seal Cond: **Roots**

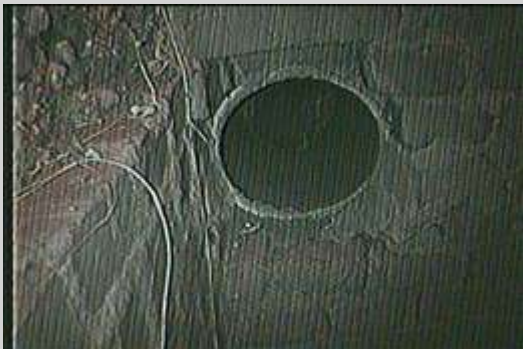
8 in. Circular Gravity Sewer Pipe In @ 5 O'Clock

Infiltration: **None** Pipe Seal Cond: **Unknown**

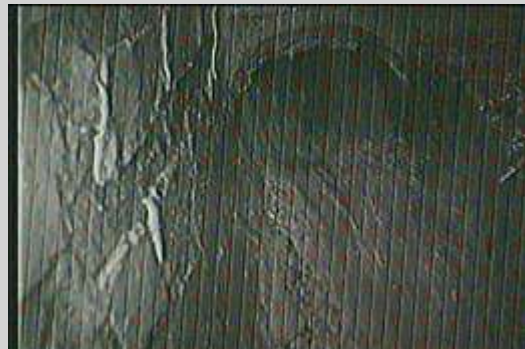
Drop In @ 5 O'Clock

Drop Condition: **Open**
